BREACHED COASTAL PONDS Geomorphology & Climate Change
Gordon Peabody, Safe Harbor, 2016, gordonpebody@gmail.com

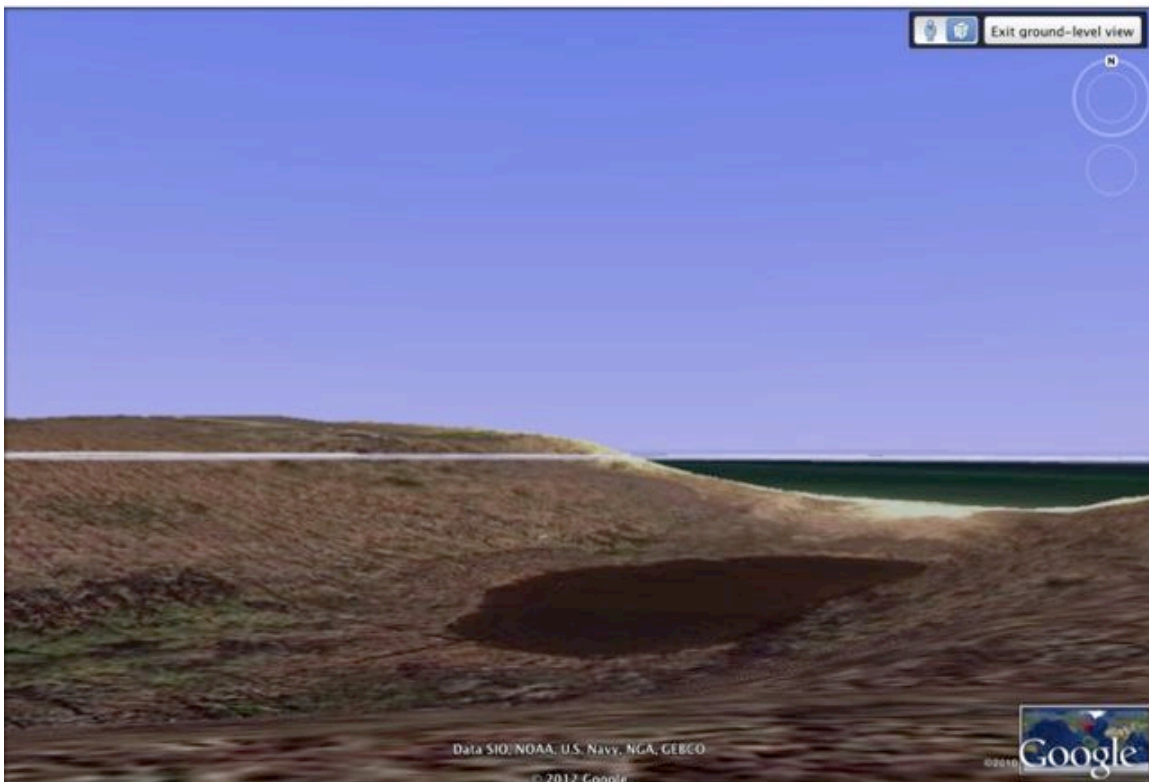
Extraordinary cross section illustrating geomorphological transition from a full size fresh water pond to a minimal, breached coastal pond. When coastal erosion removed the bank protecting the pond, volume was significantly reduced. Adjacent erosion provided a sand source for a barrier dune to form on the seaward margin. This low, saddle shape, directed onshore winds between the higher elevation coastal banks, enhancing additional, aeolian deposition of unconsolidated sediment. Recent, high energy, mega storm pulses, have contributed to overwash events at this pond.

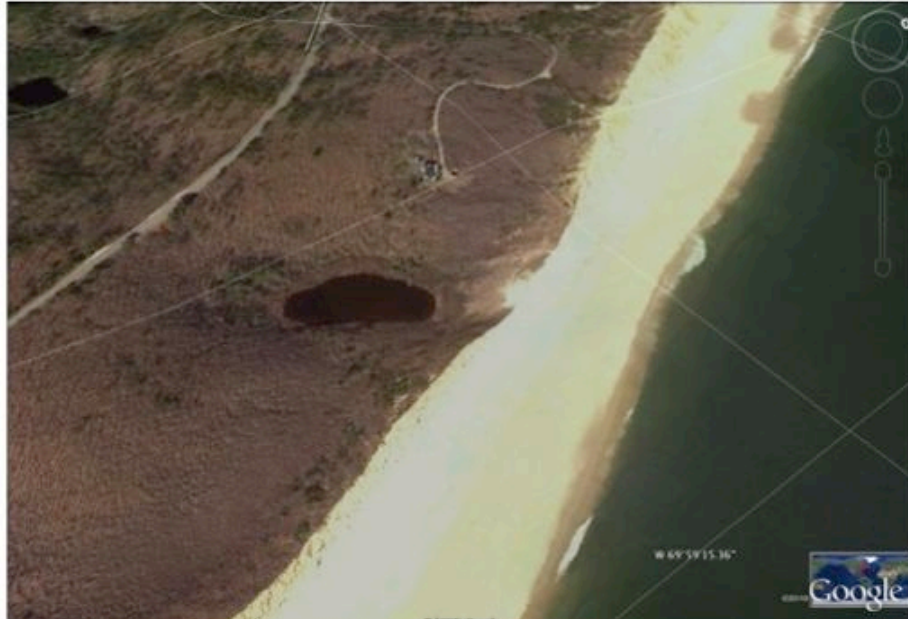
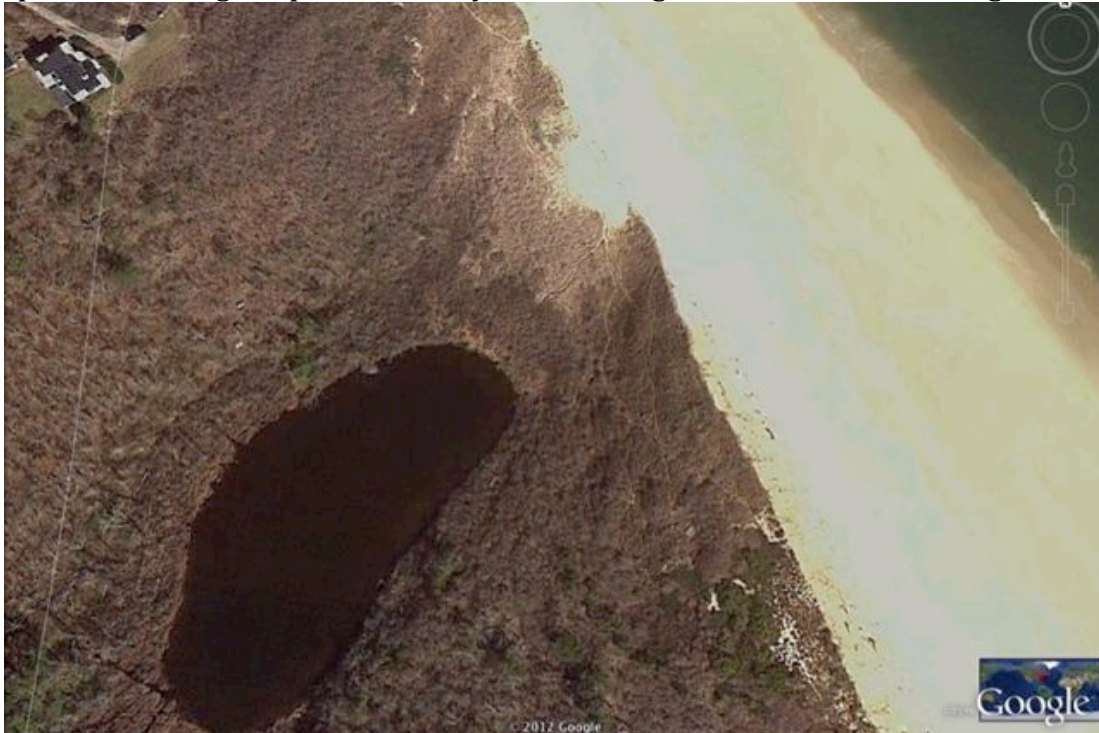
Above and below: Two perspectives of a breached pond under study. Bowl shaped depression of original pond is clearly visible. Images are before recent mega storms.

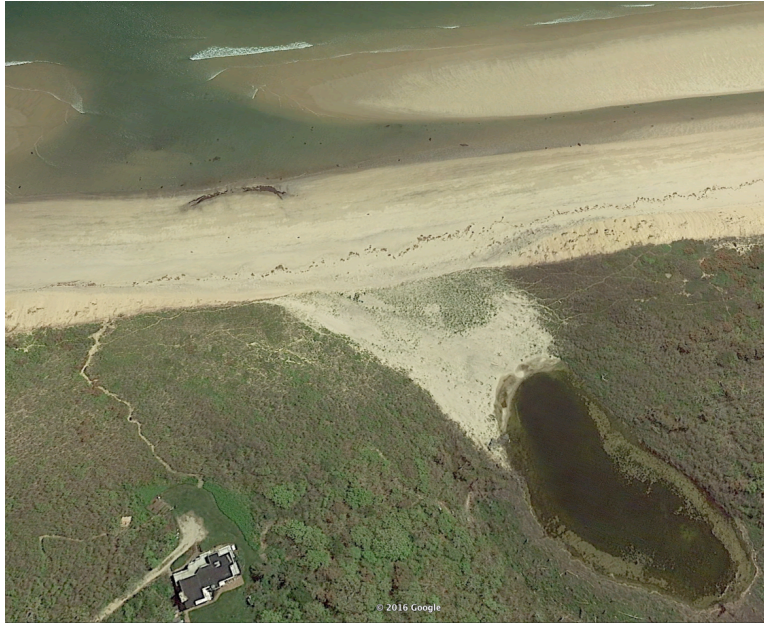
Above image shows nearshore rip channel and sandbar adjacent to this coastal pond. Sand bars are components of linked, coastal resource systems. One way they perform is by creating benthic friction, reducing storm wave heights. When onshore, storm wave loading piles water inside sand bars after the tide has turned; rip channels develop, providing equalization of SSH. During long duration storm events, wind directions may remain unchanged through multiple tide cycles. On the incoming tide, full height waves can access limited sections of coastline. We believe that many anomalous erosion events may be linked to the existence of rip channels.

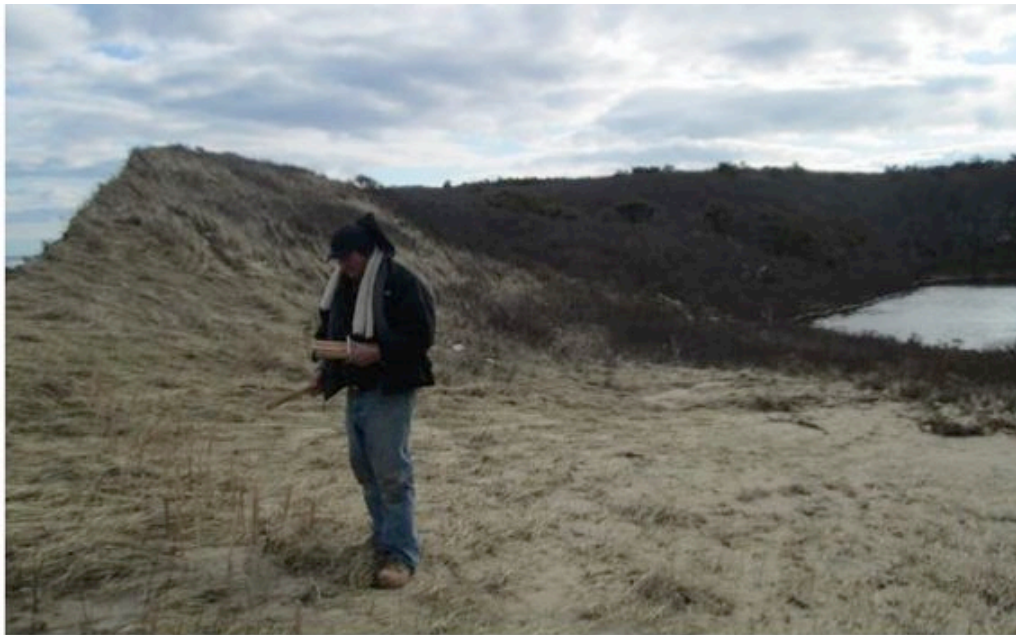
Safe Harbor image: Studying the results of a previous overwash. Note the pond in background. Note also the drop in elevations leading down to the pond. Anthropogenic impacts from hikers has contributed to overwash vulnerability.

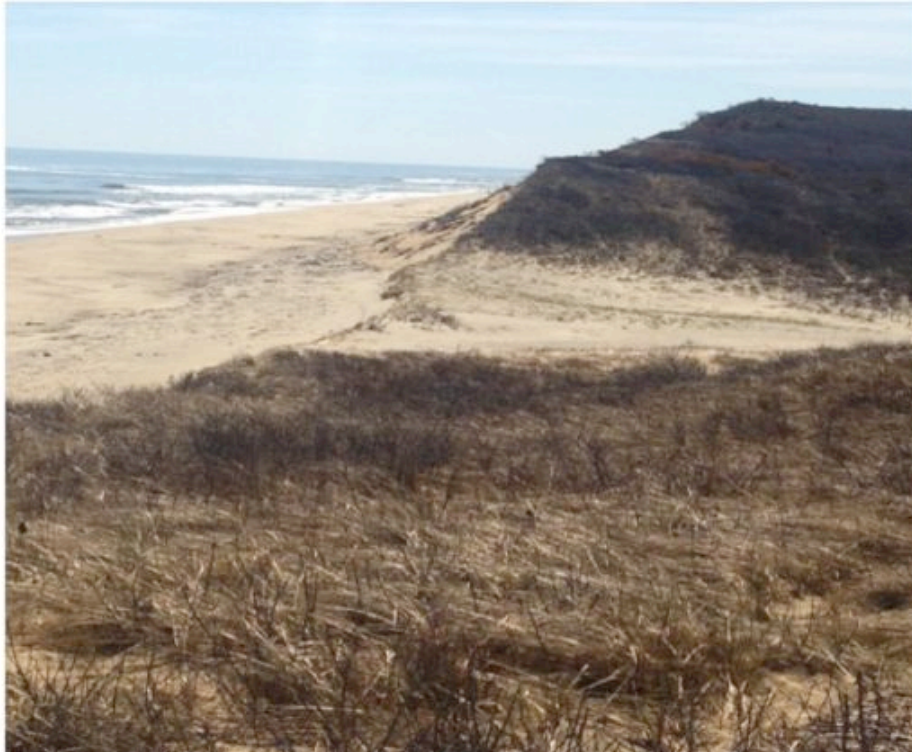
Image by G. Peabody: Barrier dune and pond margin, after several overwash events.

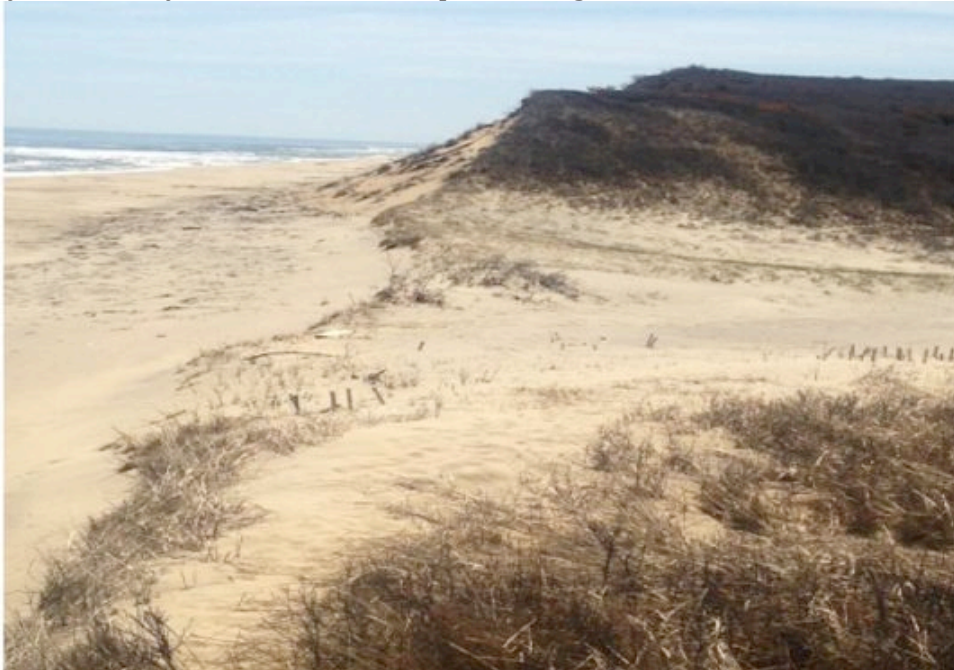
Above image details geomorphological transitioning of pond margin, barrier dune habitat. Limited area of transported sand benefitted the barrier dune elevation but the preponderance of overwash transport activity, characteristically moved sand to lower elevations. Some of this transported sand volume was added to the pond edge. Vegetation in both the low and high diversity habitats was impacted by the physical stress of deposition and chemical stress of salt water during overwash.

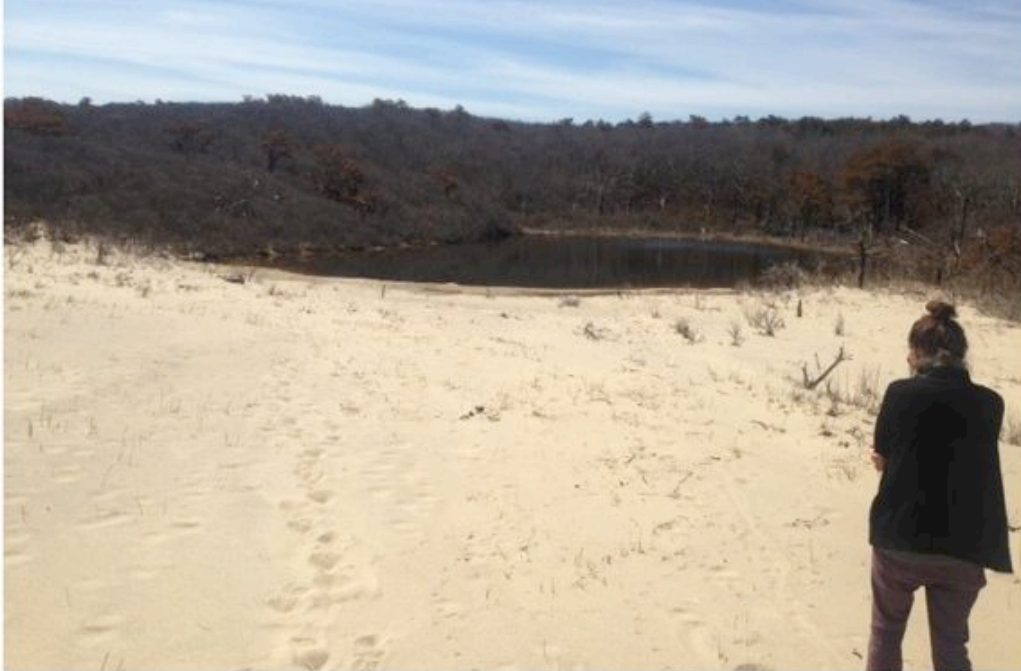
Image by G. Peabody: Approximately 18,000 sq ft, 6-800 cubic yards of overwash fan, covered the entire pond margin, from the barrier dune to the pond itself.

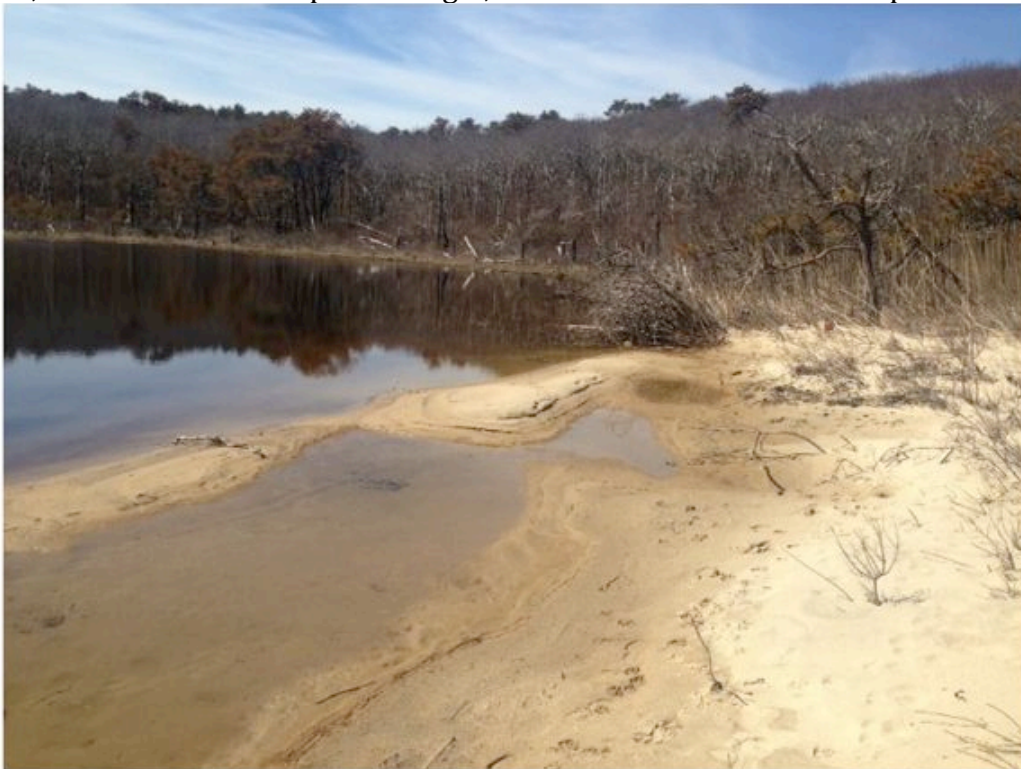
Image by G. Peabody: Documentation of overwash fan into a breached coastal pond. While this may be considered detrimental on a short time scale, the additional sand elevations may contribute to enhanced protection of the pond on a longer time scale. Because the pond margin vegetation evolved within a lower stress, exposure to salt stress resulted in 100% mortality for exposed, pond margin vegetation.

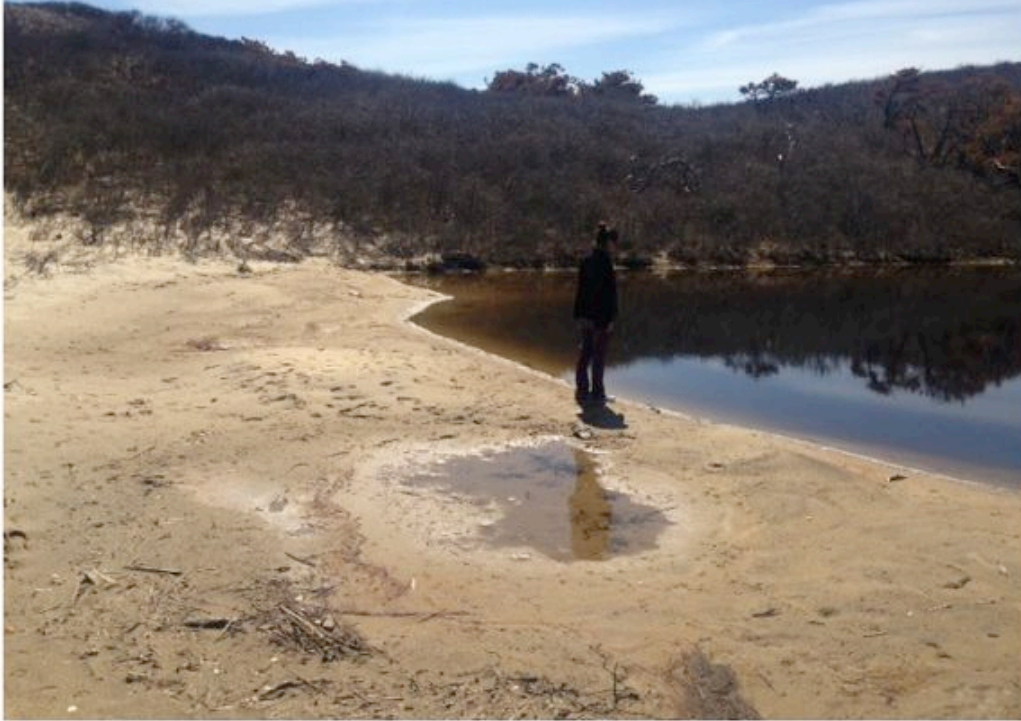
Image G. Peabody: Approximately 35 feet of the pond's seaward edge received sand.

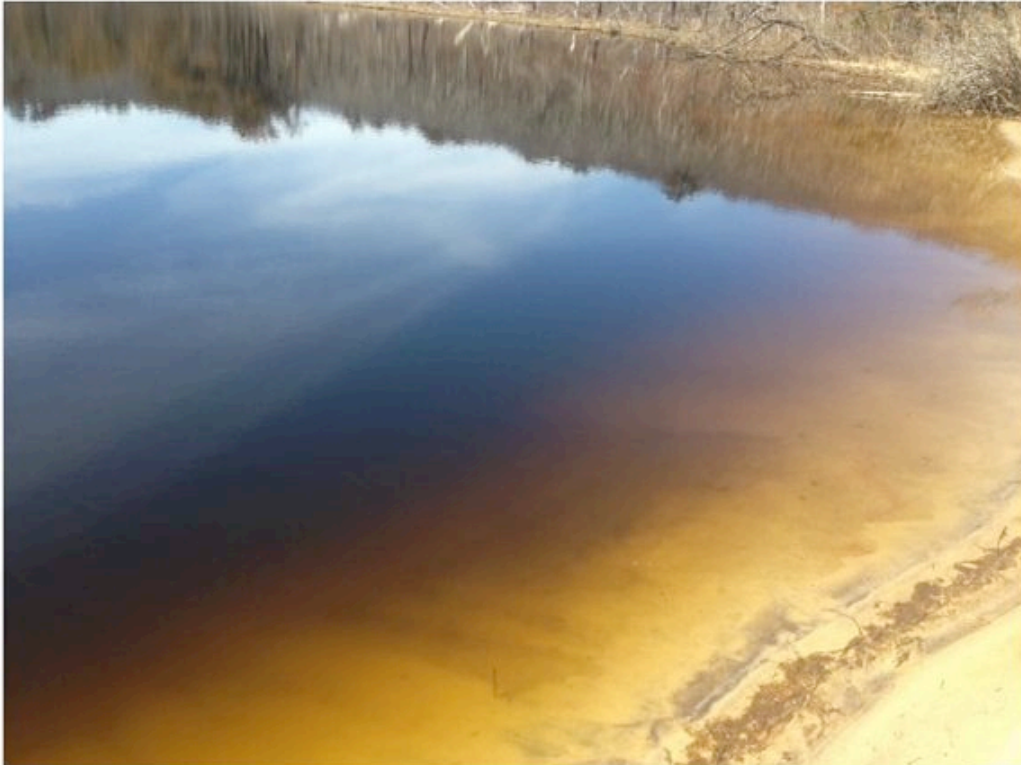
Image by G. Peabody. Benthic cores should confirm annual, windblown sand layers from winter storms and more recent, heavy layers representing overwash. We are monitoring this area to record diversity and abundance of recovery species as a way of studying some of the synergistic parameters of transitional, habitat stress.

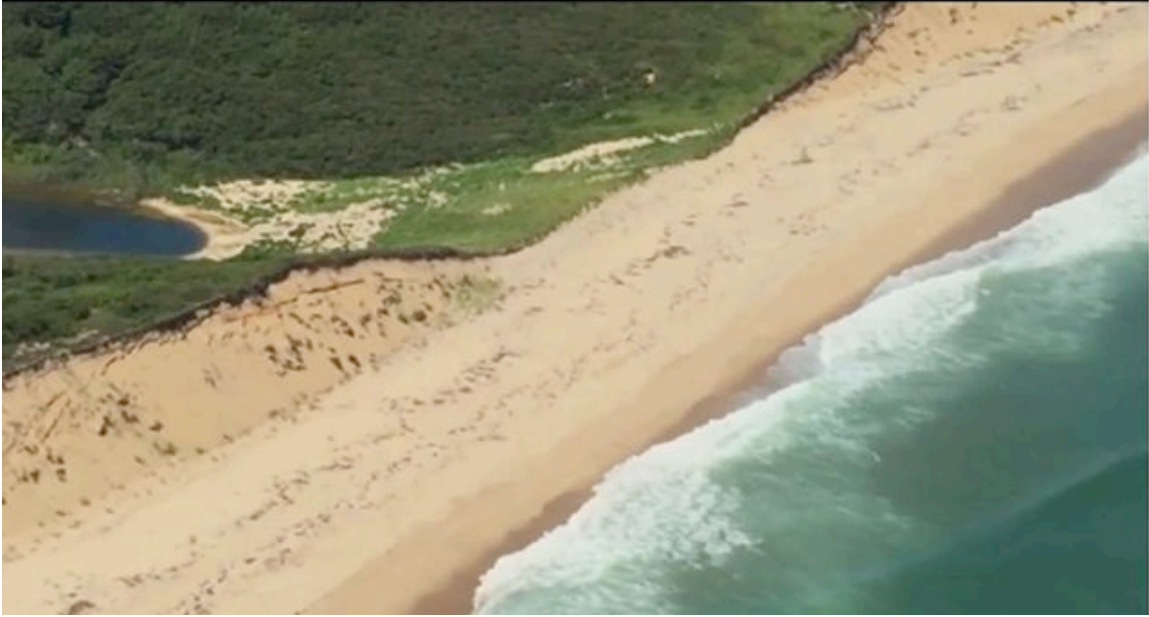
Above image shows active recovery in the low diversity, higher stress, barrier dune overwash habitat. The lower stress, higher diversity area of pond margin impacted by overwash is much slower to respond and so far has shown no recovery.

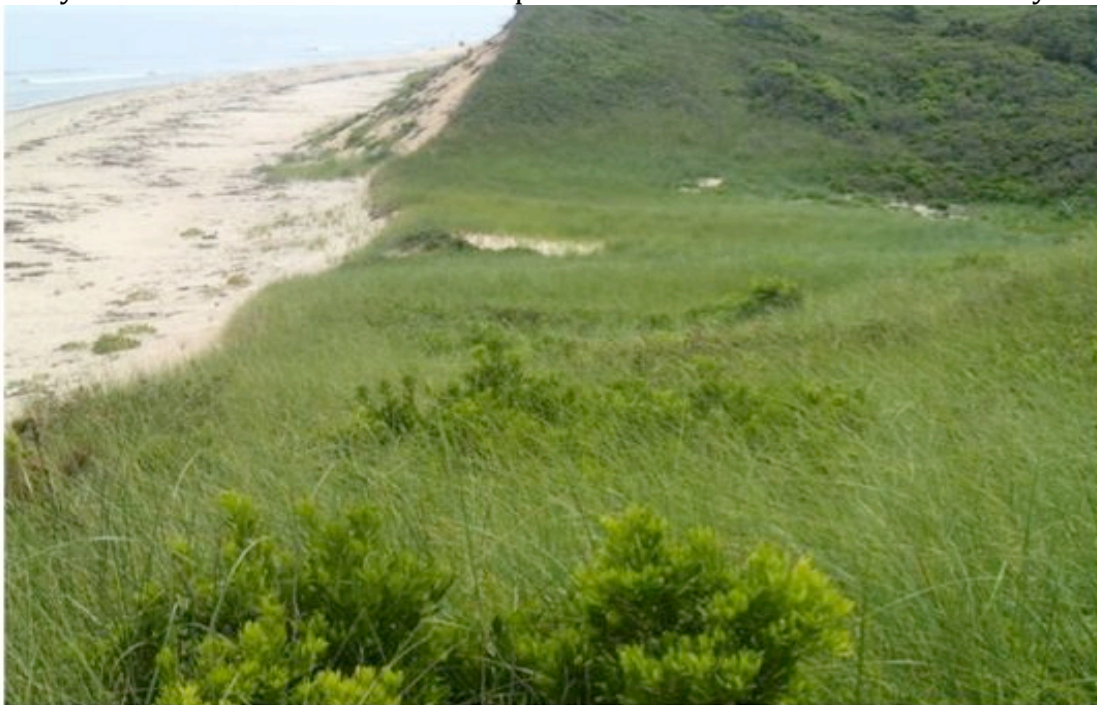
Above image by G. Peabody (taken from above overwash area) illustrates active rate of habitat recovery in high stress, low diversity, barrier dune habitat. American Beach Grass dominates. Very limited, additional diversity includes *Rugosa rose*, Beach Pea and Seaside Goldenrod. Native vegetation growing in high stress barrier dune habitat shows extraordinary stress tolerance and resilient recovery to overwash overwash events. This performance enhances habitat sustainability.

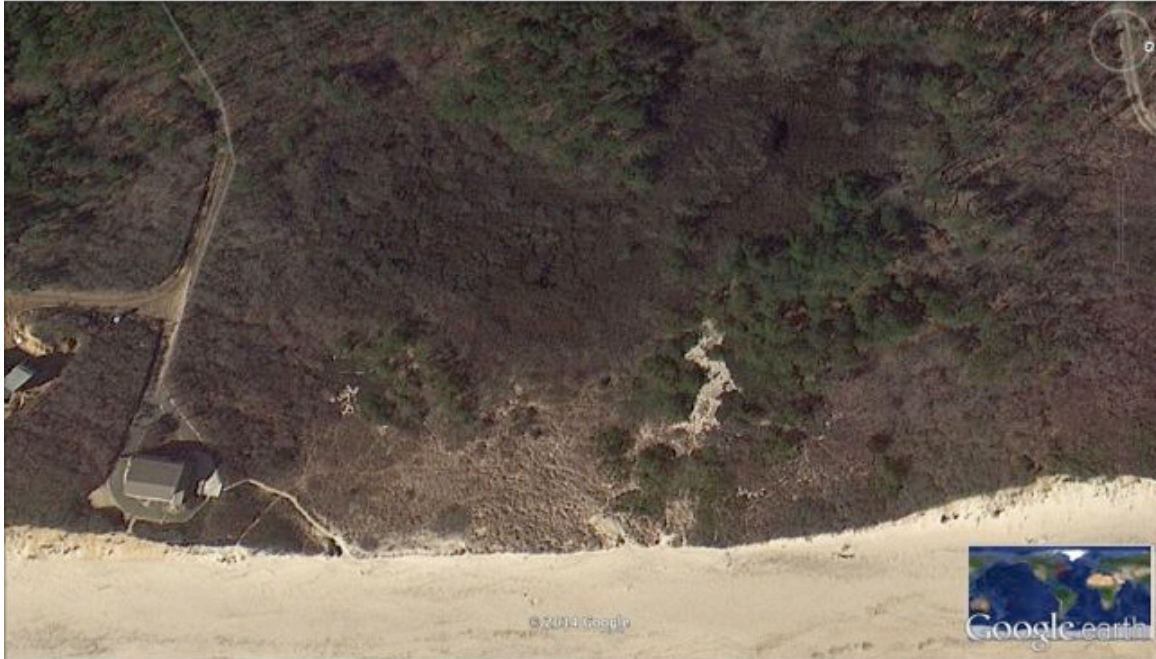
Another ocean side, breached coastal pond, including the signature barrier dune and change in patterned vegetation. This site still exhibits diversity but is geomorphologically advanced, with grown trees and only a small wetland area remaining at the center of the old pond. Hydric soils are widespread, as expected.

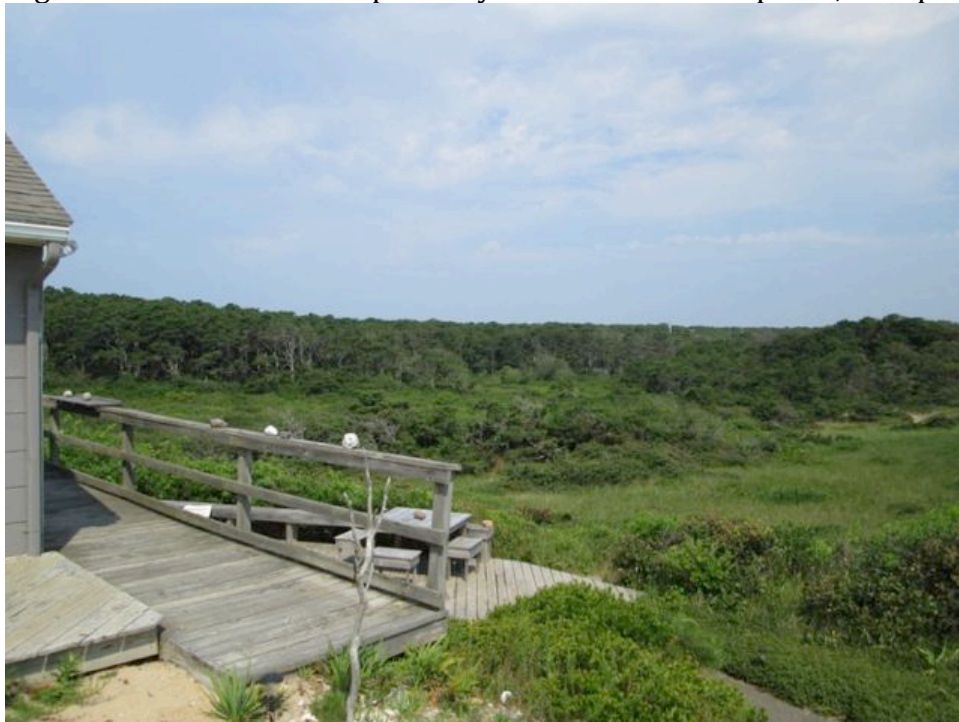
Image by G. Peabody. A lateral perspective of the breached pond basin. Intermediate stress levels have re-established in some areas, as indicated by lower plant diversity. The remaining, lower stress, high diversity, vestigial wetland area can be seen in the center of the image. The tree elevations remain below dune crest levels.

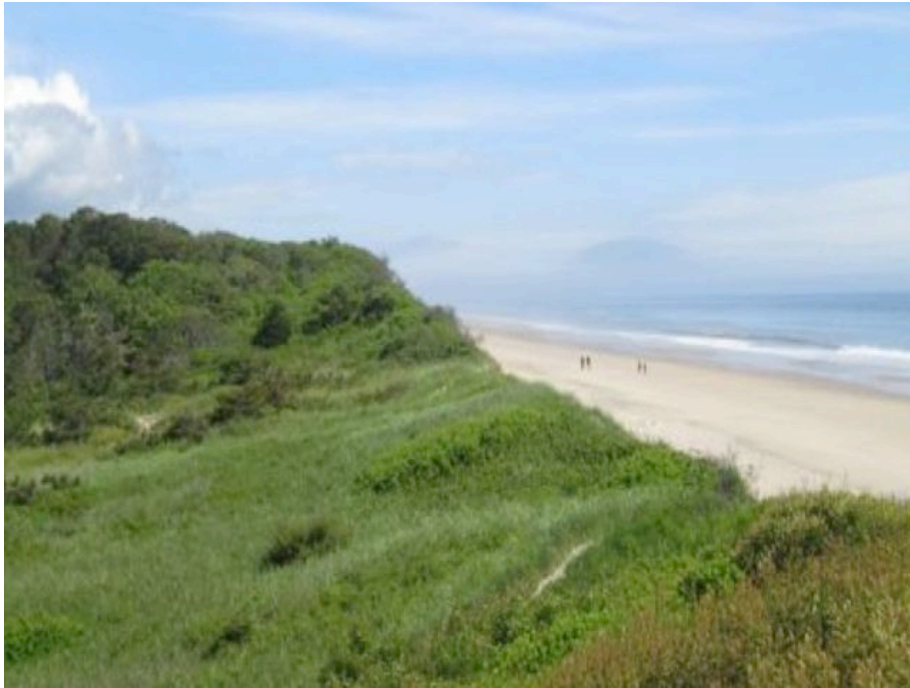
Image by G. Peabody. Barrier dune, bracketed between coastal banks, provides classical confirmation of breached pond geomorphology. This particular dune exhibits good stability, in part because of reduced anthropogenic impacts.

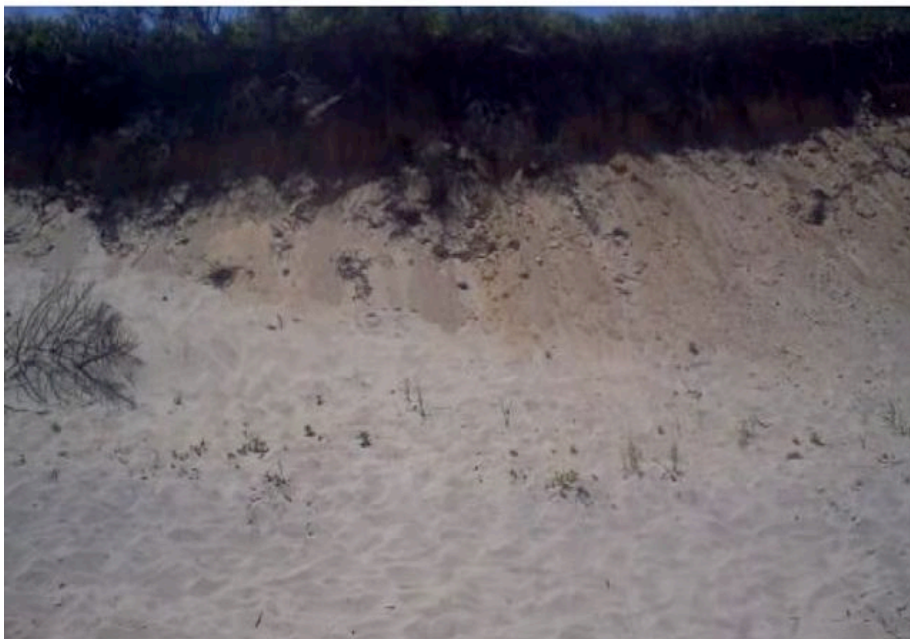
Image by G. Peabody: Characteristic breached coastal pond beachface, showing margin between coastal bank and coastal dune. Note differential sediments: Unconsolidated aeolian sediments on left; consolidated glacial sediments on right. Multiple breached ponds exist on both the ocean and bayside of Cape Cod.
