The Strength of Community Spirit

THE BALLSTON BEACH BARRIER DUNE RESTORATION PROJECT By Gordon Peabody

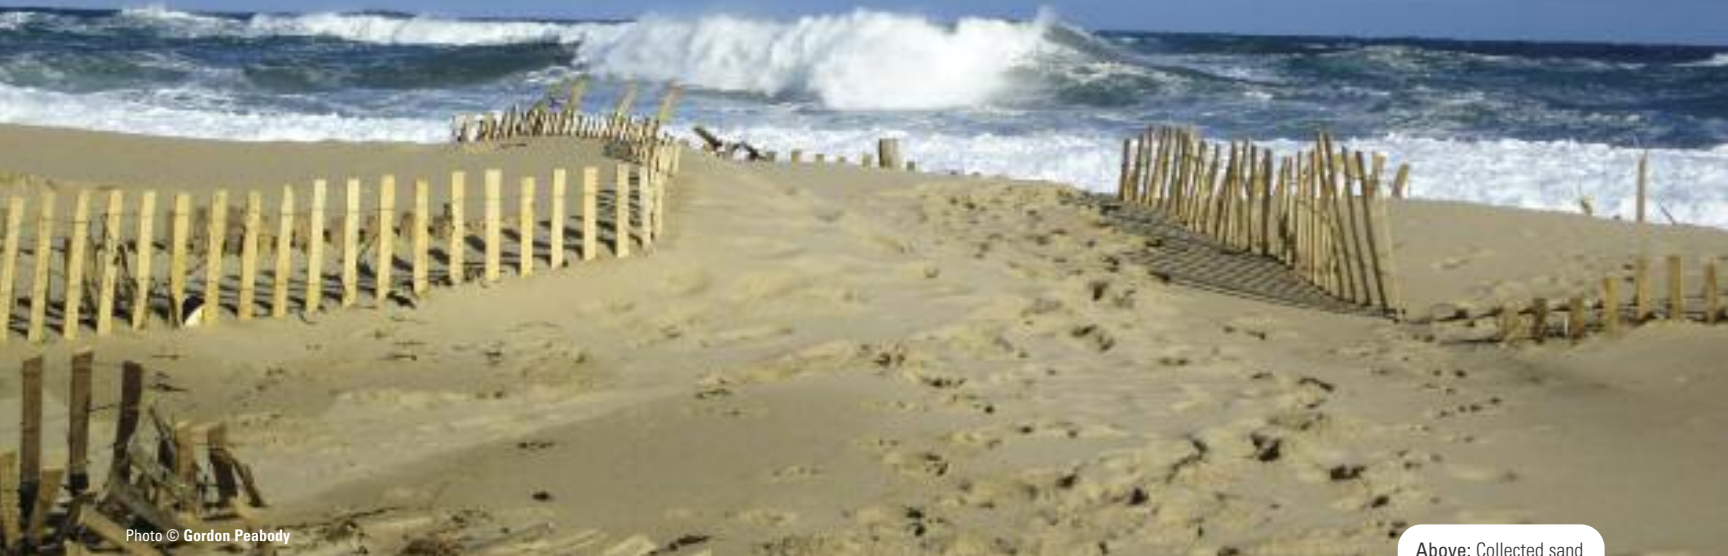
Above: Collected sand after a storm.

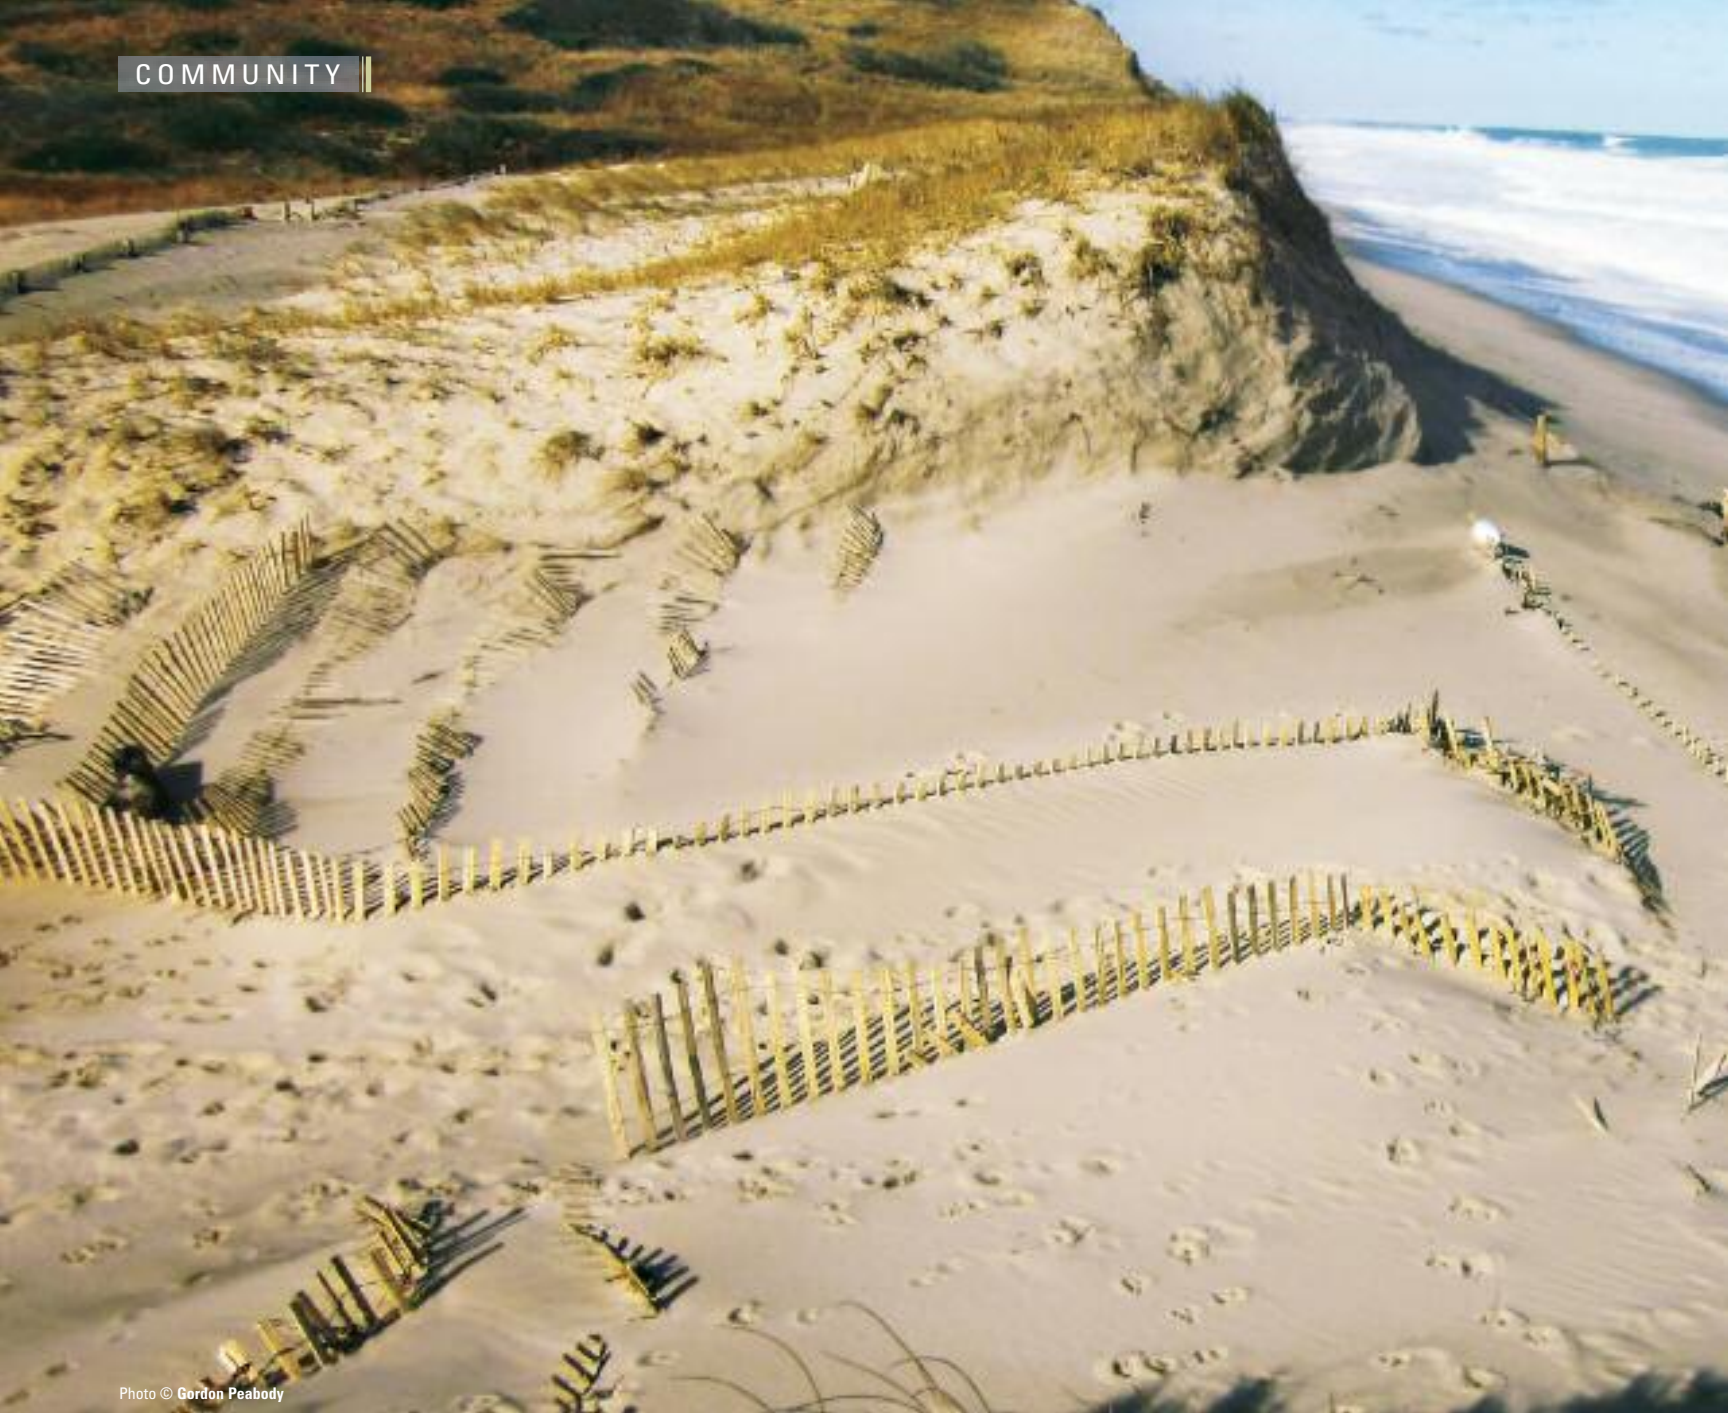
Photo © Gordon Peabody

We knew there would be risks. Gale-force winds, blowing along the coast at speeds over 35 mph, begin to pick up sand. Storm-force winds, over 48 mph, blow enough sand to obscure the first few feet of beach. This winter, the sand was already in motion but we had no way of capturing it. Two years earlier, we had developed an innovative restoration model using storm winds to restore eroded coastal habitat. This low-tech system was based on short, 24-inch sand fencing set in patterns to duplicate the wind-resistant qualities of beach grass. As sand collects, new layers of fencing can be placed to match

adjacent dune profiles. Once sand elevations are restored, American beachgrass is planted. The beachgrass stems usually double each year and the grass has no problem growing up through collected sand. Within four years, the grass will begin performing on its own. Pedestrian access is also reconfigured, into a zigzag pathway to prevent a repetition of “shotgun blow outs.”

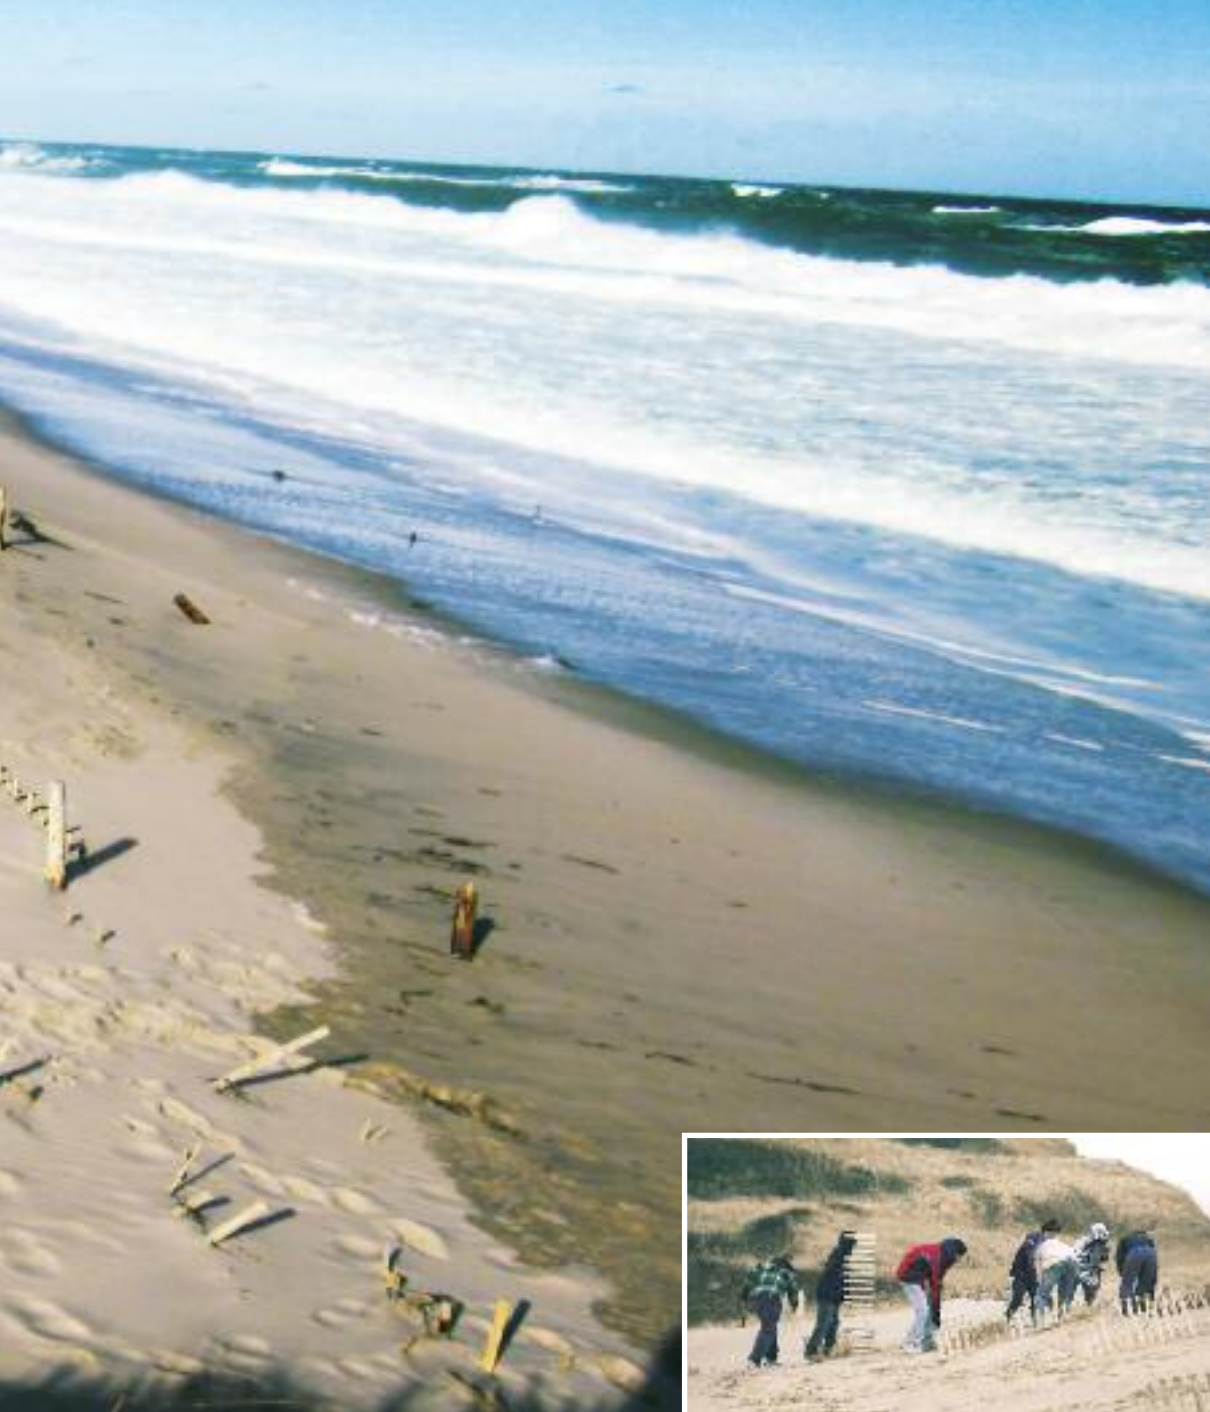
Above: Unexpected amount of sand collected by matrix fence system. Bottom Left: Harwich High School Environmental Studies class worked on restoration.

installation. Ten days later, following a big ocean storm, several phone calls came into our office informing us that nearly all of our sand-collection fences were gone. It took a few days before I finally mustered up the courage to go out to the beach and see for myself. It was mid-afternoon on Christmas Eve. The fences were gone all right, buried beneath two feet of collected sand!

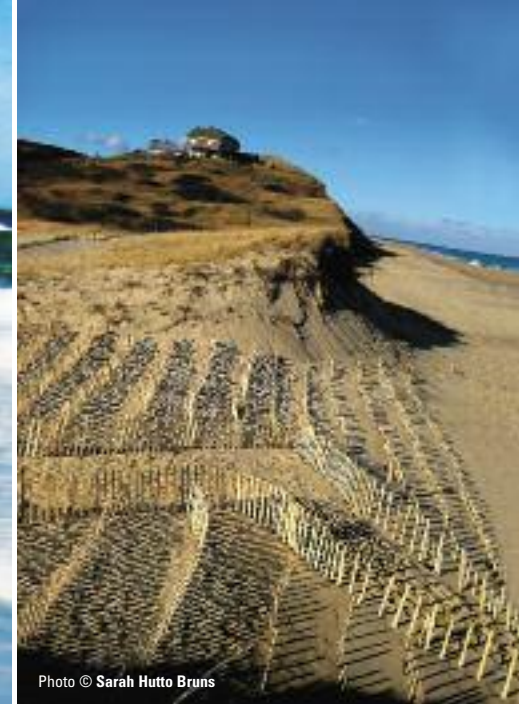
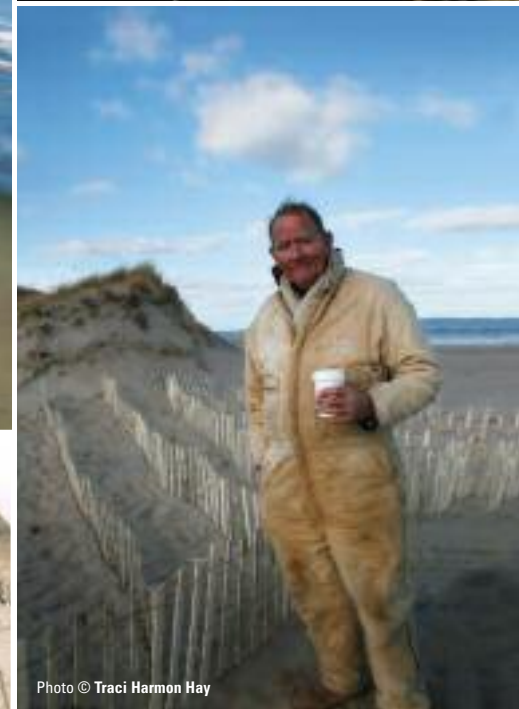
demand. Then two weeks later, the site was ready for a third set. Bob Byrnes, a Truro resident and teacher at Harwich High School, stepped up with his environmental studies class to provide volunteer labor for installation of the third set of sand-collection fences. The enthusiasm of these students caught the attention of the whole community.
